UNITED STATES MARINE CORPS
III MARINE EXPEDITIONARY FORCE
UNIT 35601
FPO AP 96382-5601

Subj: COMMAND INVESTIGATION INTO CIRCUMSTANCES SURROUNDING THE
ACTIVATION AND RELEASE OF FIRE SUPPRESSION IN HANGAR ABOARD
MARINE CORPS AIR STATION FUTENMA ON 10 APRIL 2020

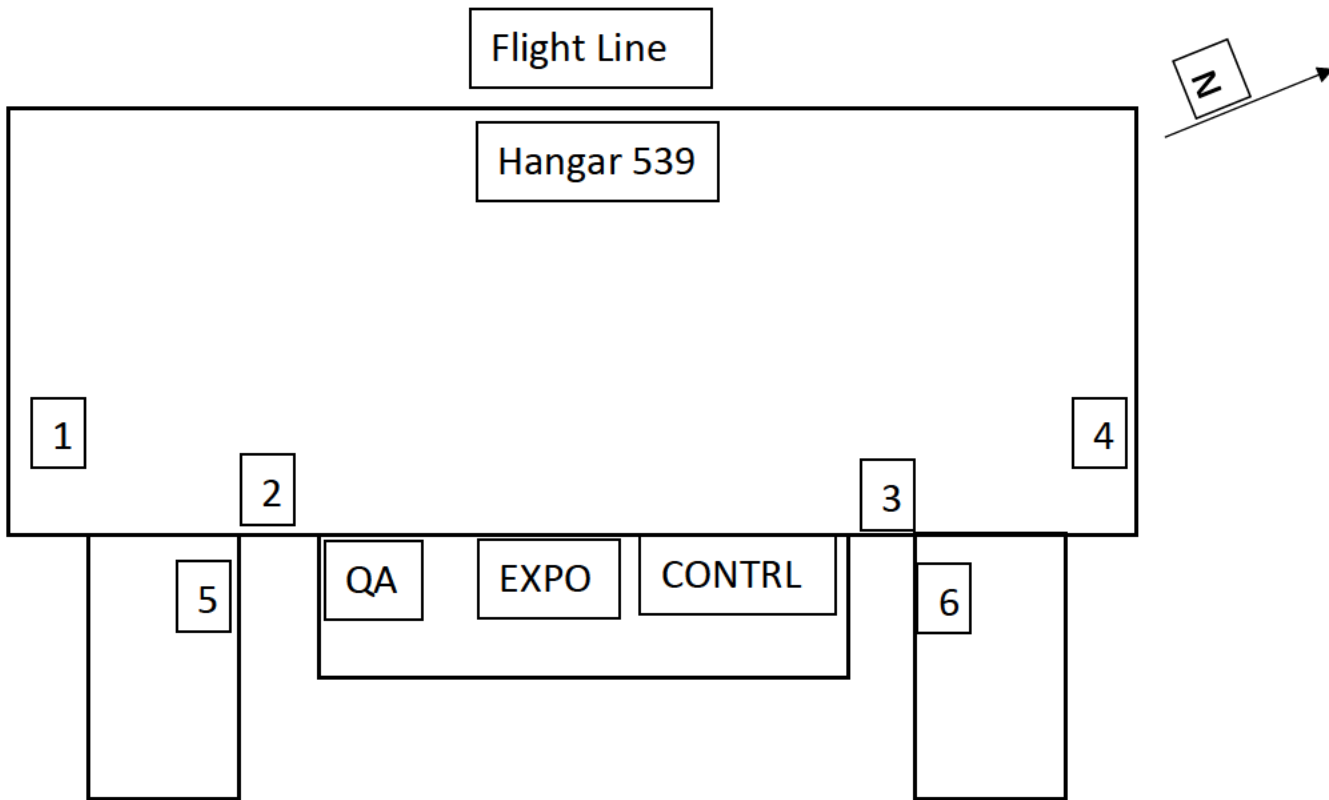
Around 1630-1640, myself and other Marines were in Room 109, Building 539, talking when the fire alarm went off. The following diagram and description explains which Marines pushed what buttons in an attempt to stop the flow of foam into hangar 539.

1. (b)(3), (b)(6), (b)(7)(c) Press and held switch #6 for 10 seconds.
2. (b)(3), (b)(6), (b)(7)(c) Press and held switches # 5 and #6 for 10 seconds each.
3. (b)(3), (b)(6), (b)(7)(c) Repeatedly pressed switch #4.
4. (b)(3), (b)(6), (b)(7)(c) - Press and held switches #1, #5 and #6 for 5 seconds each.
5. (b)(3), (b)(6), (b)(7)(c) Press and held switch #5 for 15 seconds.
6. (b)(3), (b)(6), (b)(7)(c) Press and held switches #3 and #6 for 20 seconds.
7. (b)(3), (b)(6), (b)(7)(c) Pressed and held switches #2 and #5 for 10 seconds.
8. (b)(3), (b)(6), (b)(7)(c) Press and held switch #3 for 5 seconds.
9. (b)(3), (b)(6), (b)(7)(c) Press and held switch #6 for 10 seconds.
10. (b)(3), (b)(6), (b)(7)(c) Press and held switch #2 and #4 for 30 seconds.
11. (b)(3), (b)(6), (b)(7)(c) Press and held switches #5 and #6 for 20 seconds.
