Final Preliminary Assessment Report Camp Johnson Colchester, Vermont

Perfluorooctane-Sulfonic Acid (PFOS) and Perfluorooctanoic
Acid (PFOA) Impacted Sites
ARNG Installations, Nationwide

April 2019

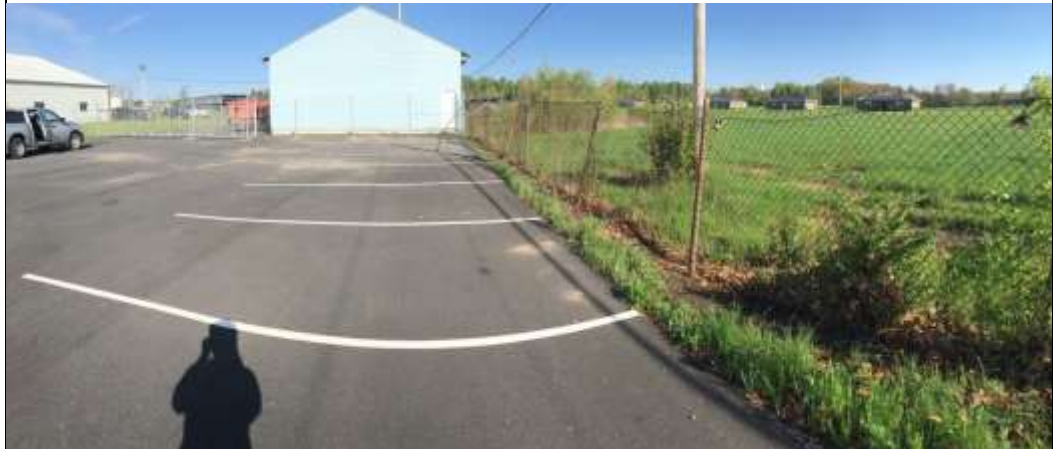
View of Building 2908. View to the northwest.

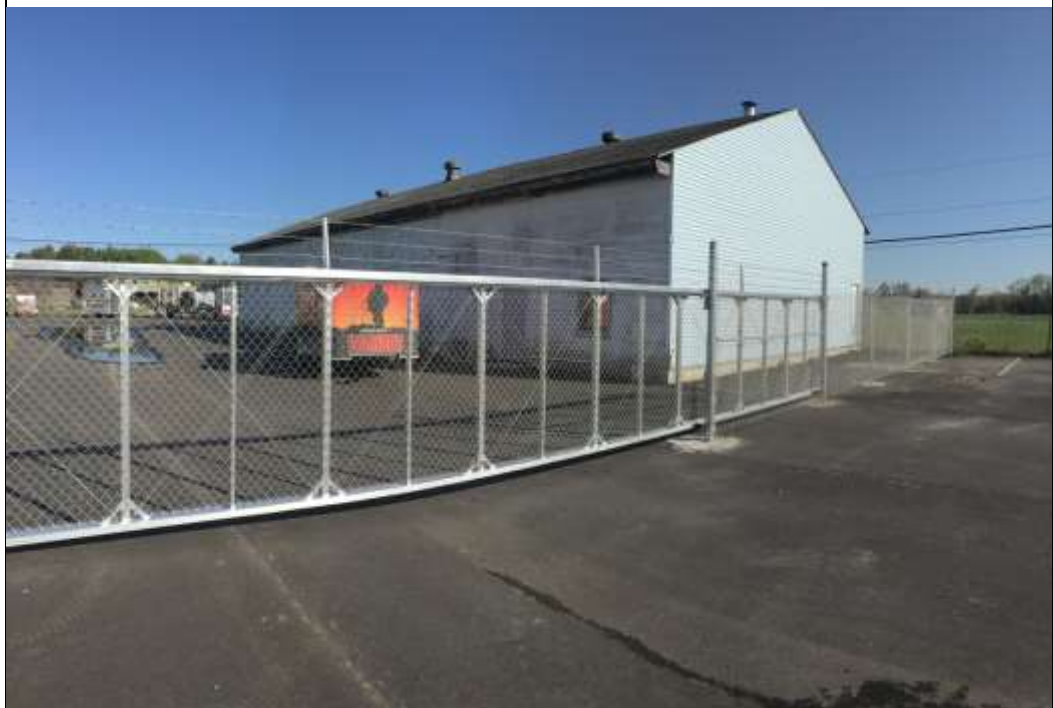
Photograph No. 2

Building 2908. View to the north.

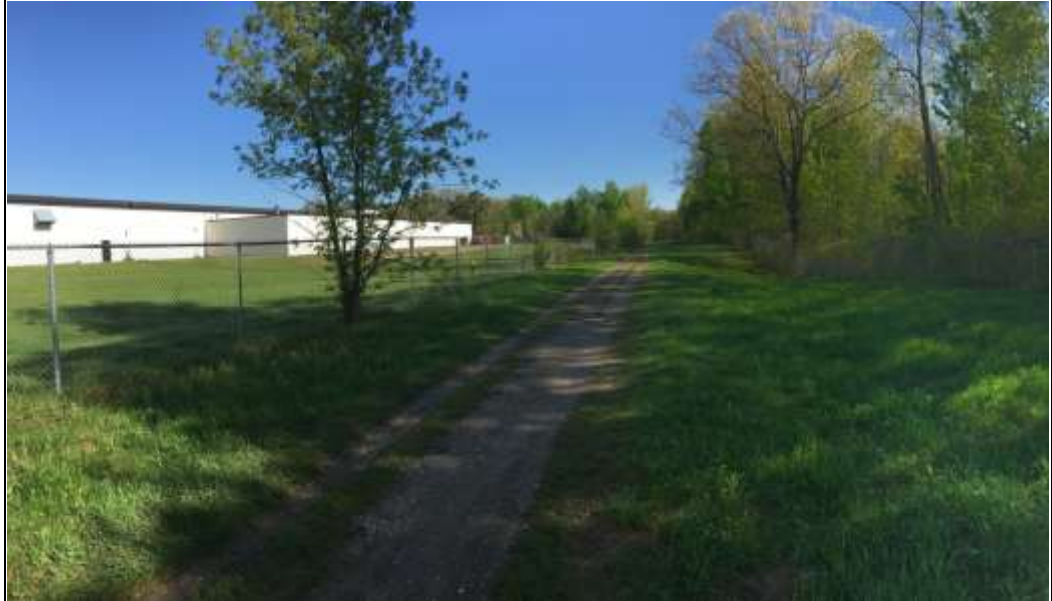
Sunny Hollow Trail between Champlain Cable Company (left side of photograph) and Camp Johnson (right side of photograph). View to the north.

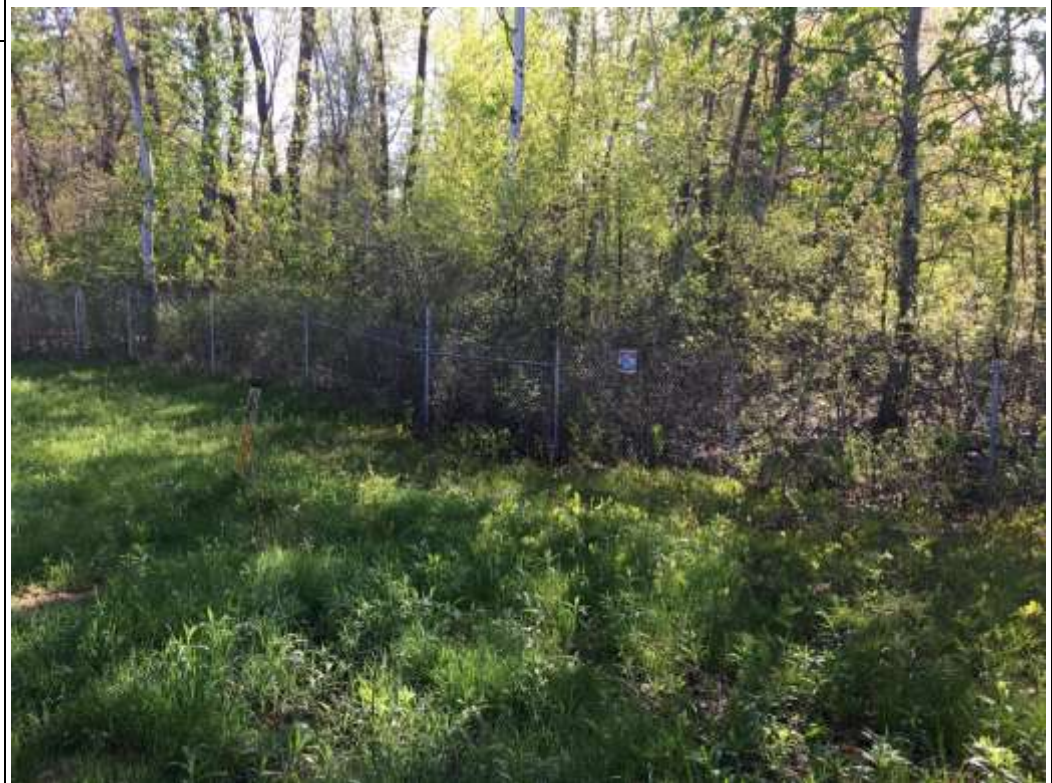
Photograph No. 4

View of Camp Johnson's western property boundary adjacent to Sunny Hollow Trail.

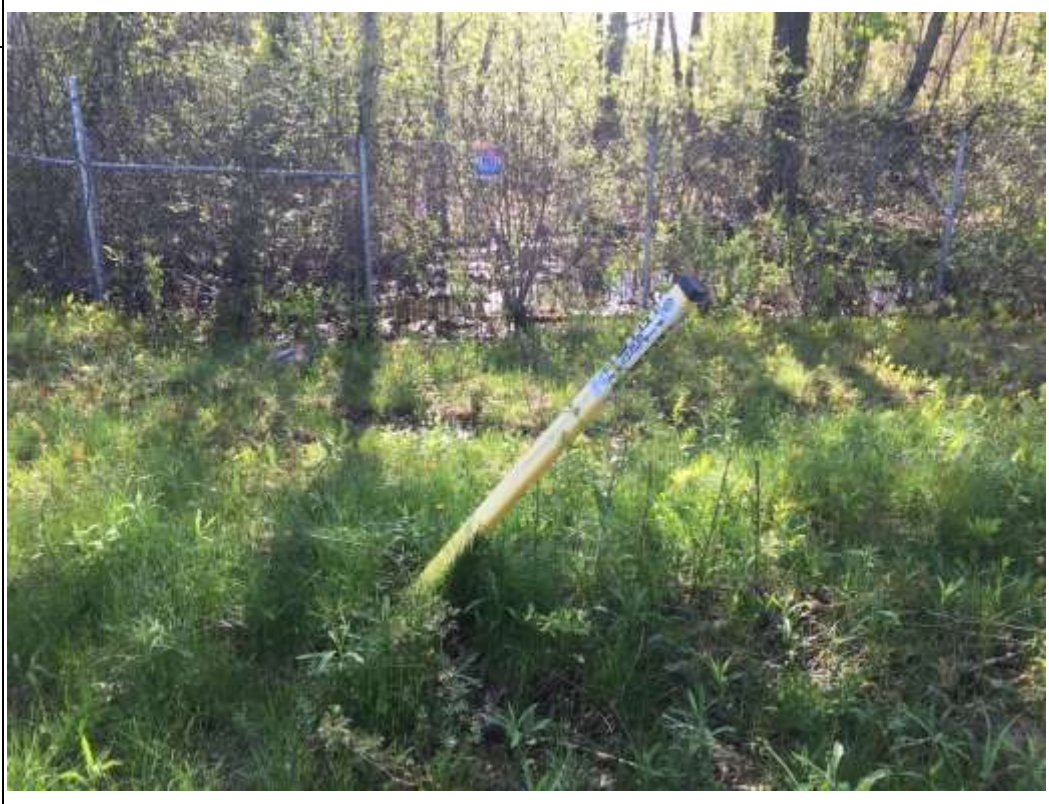
Photograph No. 5

Description:
View of low lying areas with ponded water adjacent to Sunny Hollow Trail and Camp Johnson's western property boundary.
